CLAYMEX SPANISH PROFILE TILE  
ICE BALL IMPACTING  
ANSI FM 4473  
HAAG FILE: 5111000240-142/198

JULY 18, 2011

Re: Claymex Spanish Profile Tile  
Ice Ball Impacting  
ANSI FM 4473  
Haag File: 5111000240-142/198

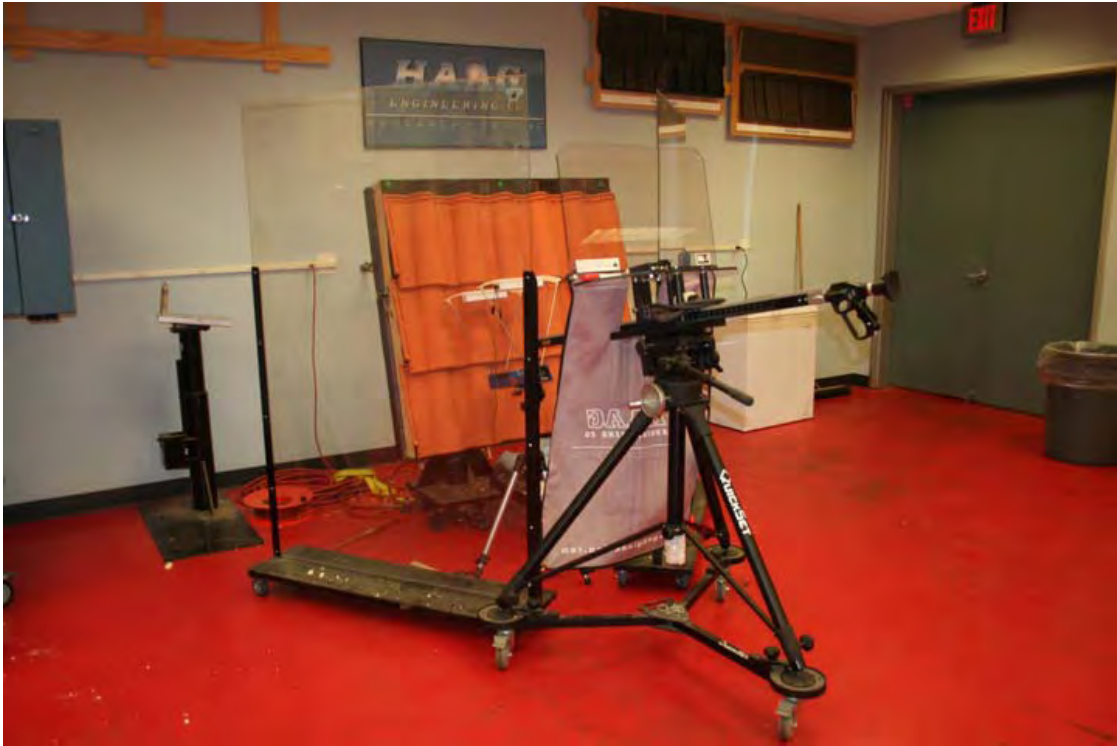
A-1. Overview of test setup.

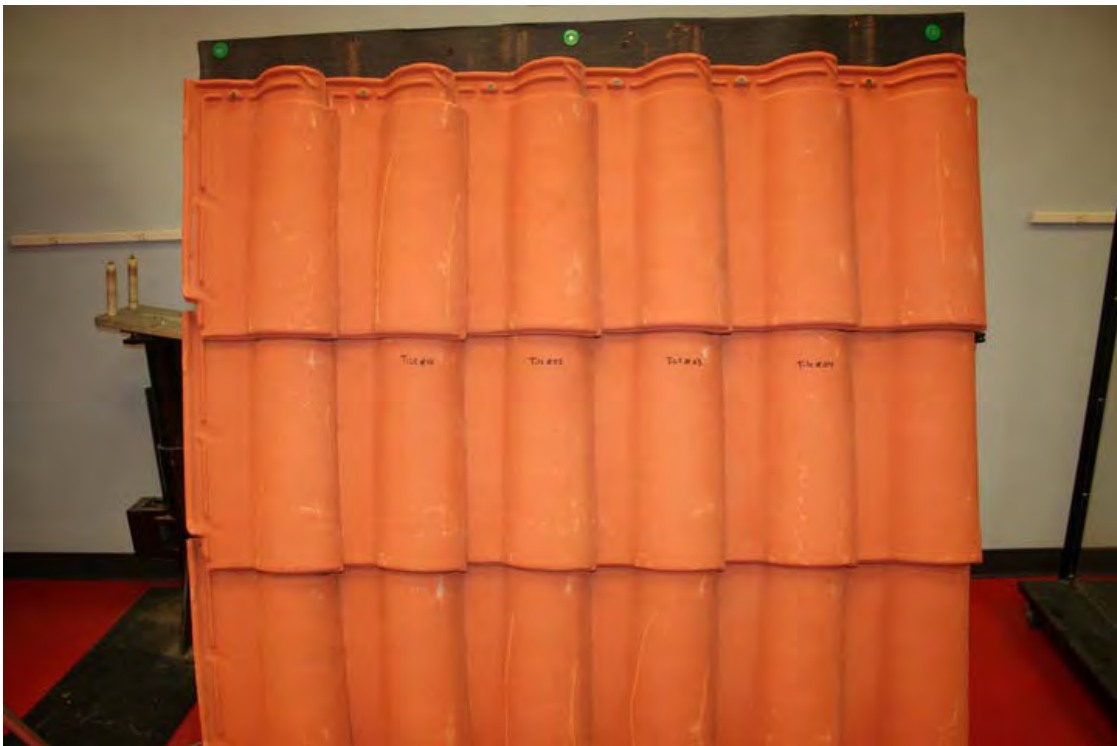
A-2. Overview of test panel with tiles 1, 2, 3, and 4 before impacting.

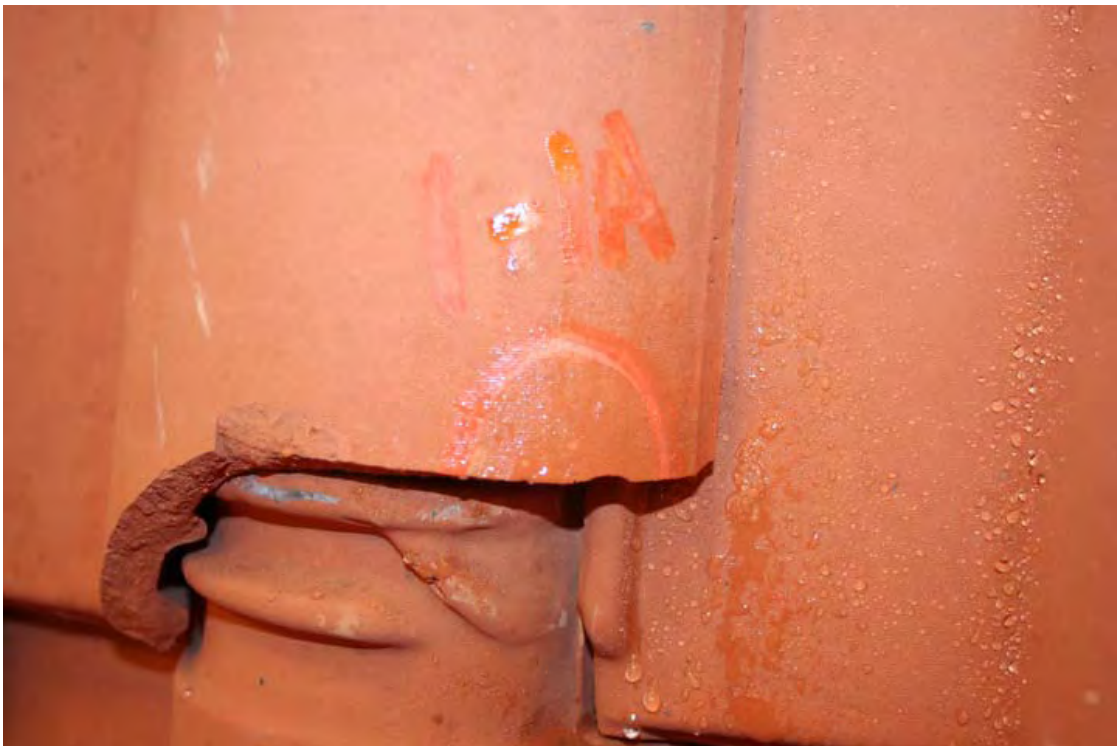
3A	Field	1-3/4	0.0975	103.90	16.36	No distress
4	1	Corner	1-3/4	0.0935	103.60	15.60	No distress
	1A	Corner	1-3/4	0.0940	102.90	15.47	Fracture
5	1	Corner	1-3/4	0.0930	103.90	15.60	Fracture

1. The Claymex Spanish Profile Tile achieved a Class 2 rating in accordance with the ANSI FM 4473.
2. The tile area most sensitive to impact-caused damage was the corner target.

A-48. Tile 4 at impact 1A with 1-3/4 inch ice ball; note fracture.

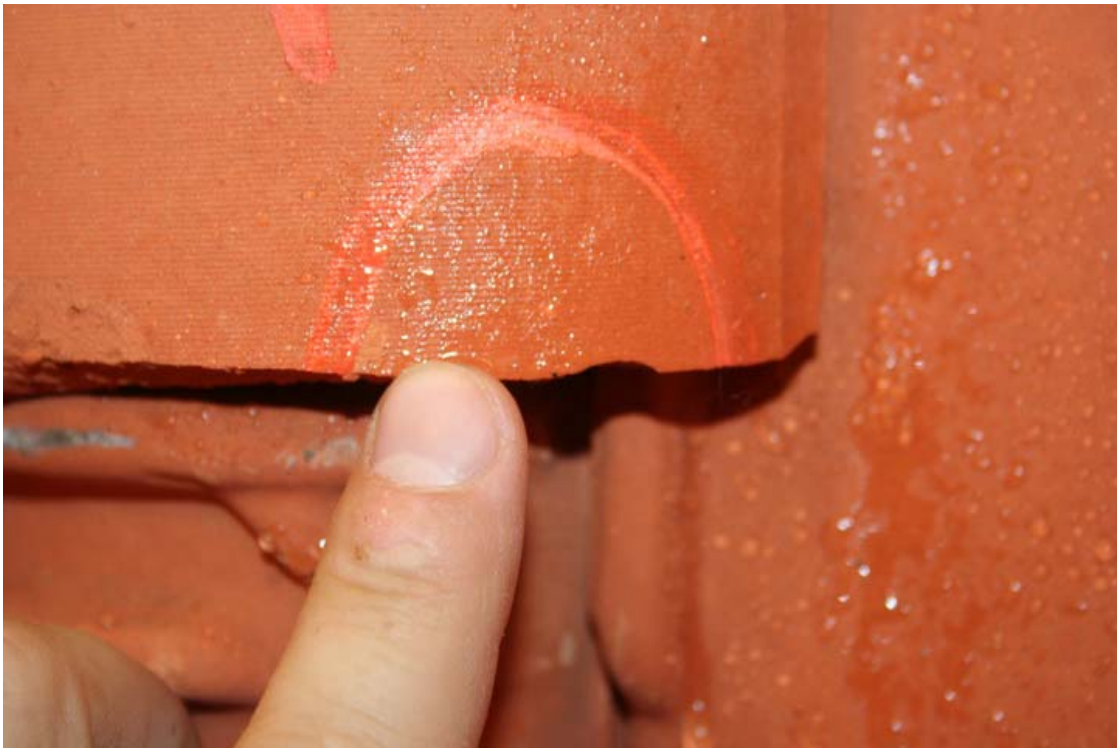
A-49. Close up of photograph A-48.

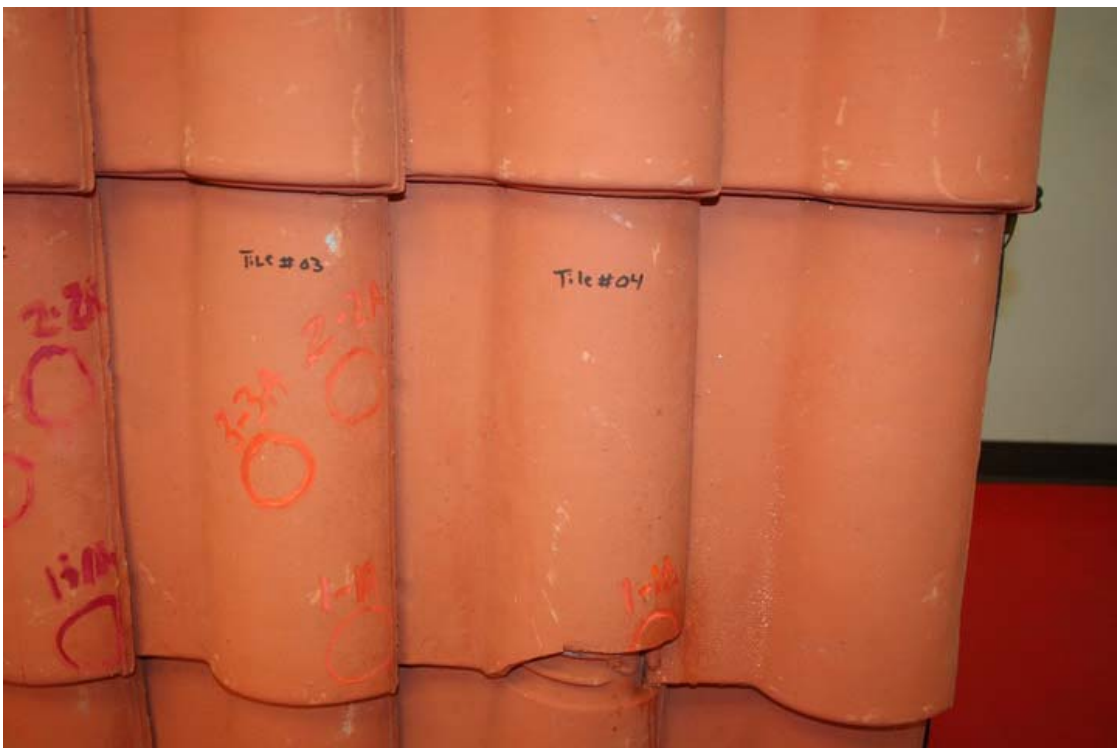
A-50. Top of tile 4 after impacting.

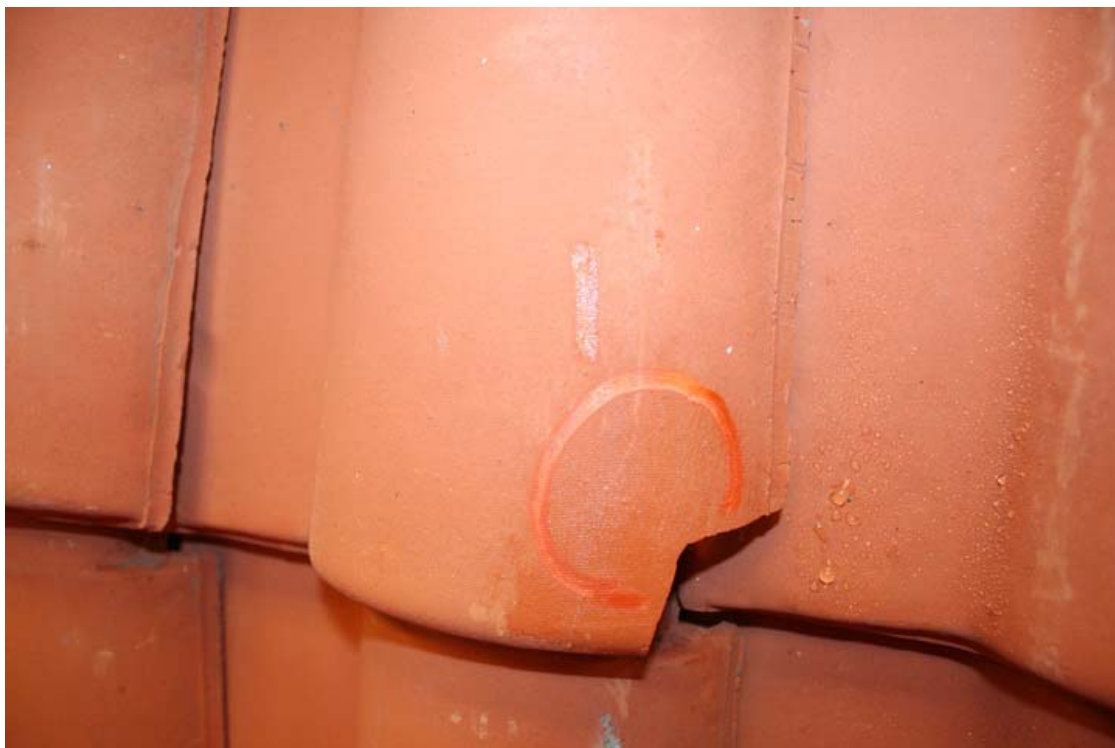
A-52. Tile 5 at impact 1 with 1-3/4 inch ice ball; note fracture.

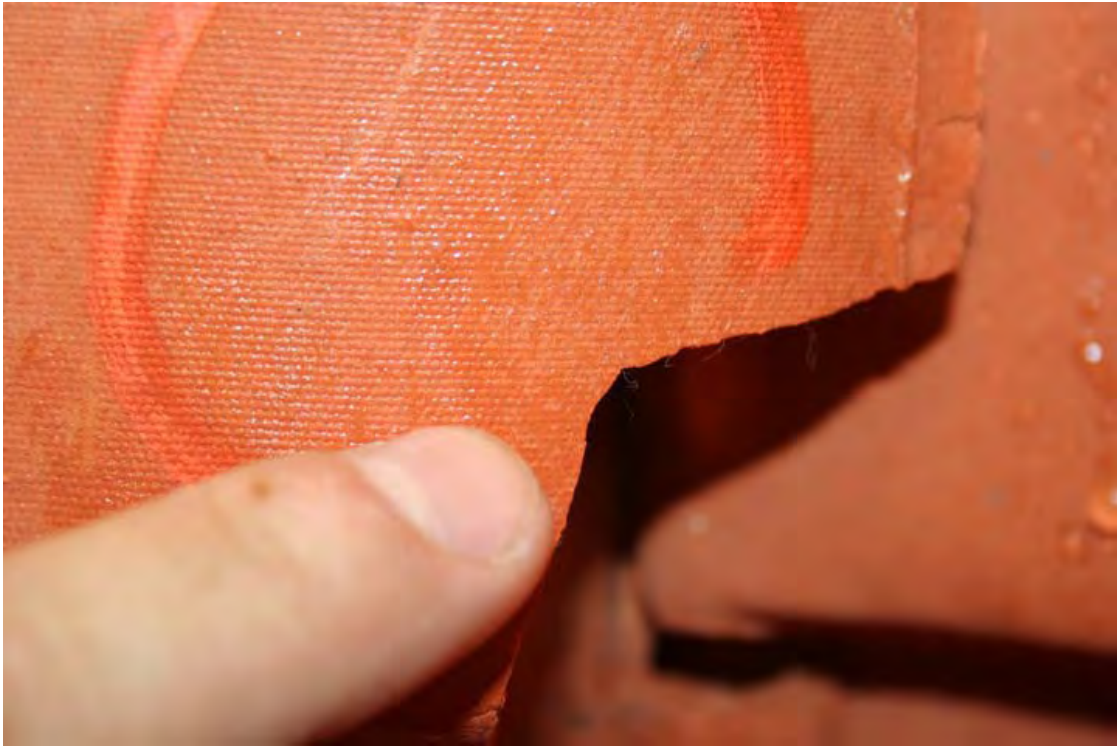
A-53. Close up of photograph A-52.

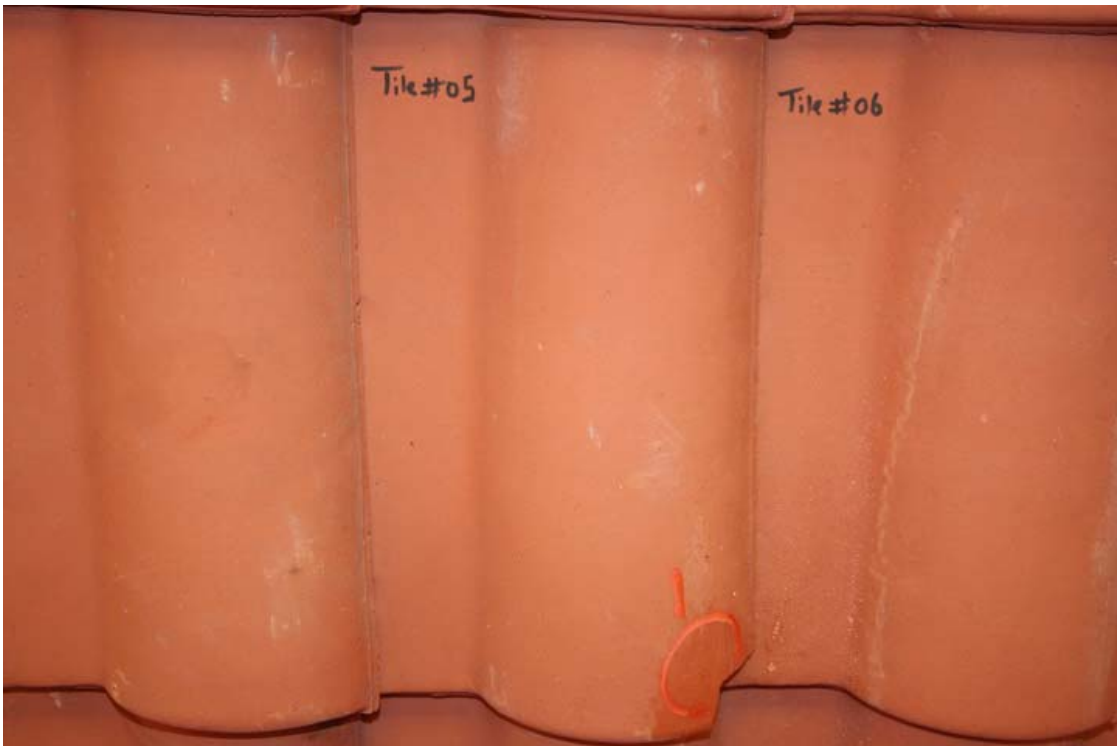
A-54. Top of tile 5 after impacting.
